Hydraulic Vane Pump Troubleshooting Booklet

Catalog 2020

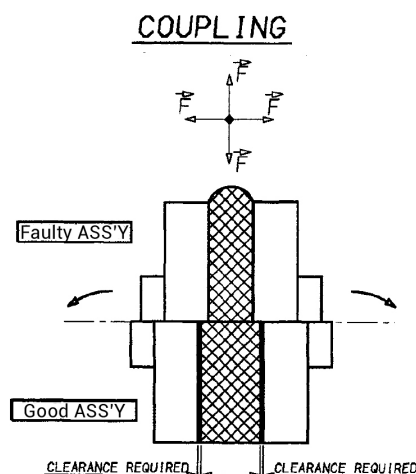
II-1-1-1. Too tight gap between the two coupling flanges (axial loads / radial loads).

| - Fretting corrosion | p9, II-2-1 |
| - Shaft rupture | p9, II-2-2-1 |
| - Ball bearing worn out | p11, II-2-5-1 |

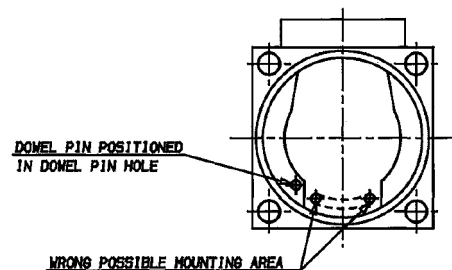
II-1-3. Cartridge dowel pin not positioned correctly in the housing.

- Dowel pin rupture
- No pressure possible
- Unconstant flow
- Noisy

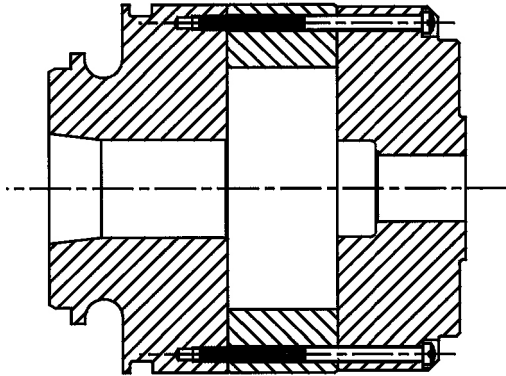
II-1-4. Incorrectly mounted cartridge screws. With any cartridge modifications, caution must be taken to check that the rotor/ vanes can rotate freely. Vanes can potentially tilt and in this case, would be squeezed in between the port plates.

- Vane marks
- Vane marks

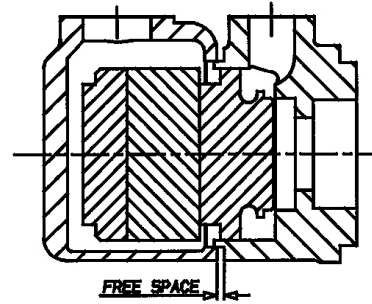
II-1-6. Loose pump screws (after modifying the pump, the screws were not tightened at the proper torque and worked loose).

- Broken screws

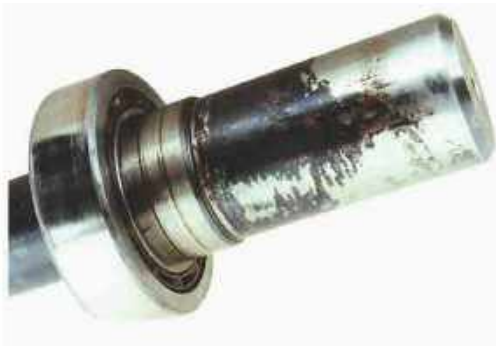
II-2-1. Fretting corrosion :

Fretting appears when the solicitations are great and when there is a slight vibration movement. These movements will "create" metallic oxides. Being very abrasive, they will weaken the structure of the component and will favour start-up of the fatigue rupture (twisted).

- Bad shaft/ coupling link
- Bad coupling manufacturing
- Bad grease when assembly

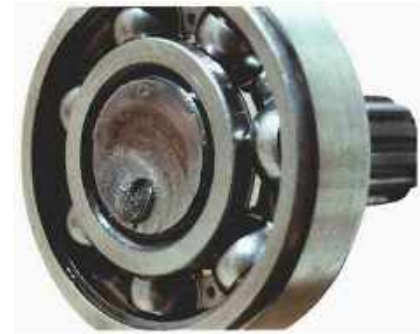
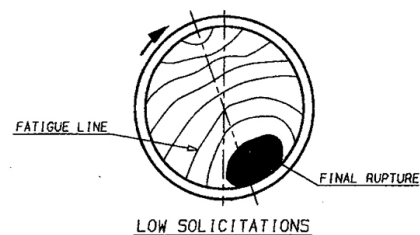
II-2-2-2. Perpendicular, over-center rotational bending fatigue rupture.

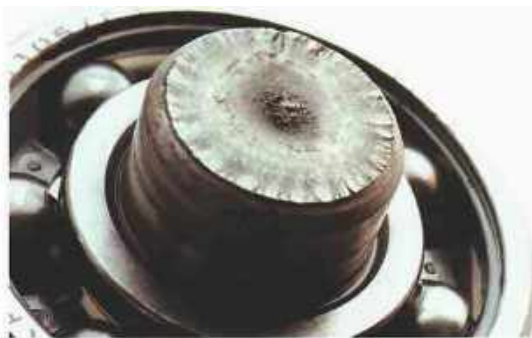
II-2-2-1. Perpendicular, center, rotational bending fatigue rupture.

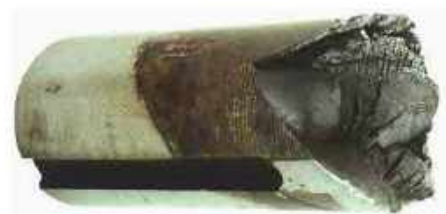
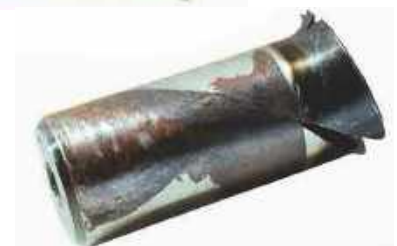
II-2-2-3. Twisted torsional rupture.

- Fretting corrosion
- Over torque limits

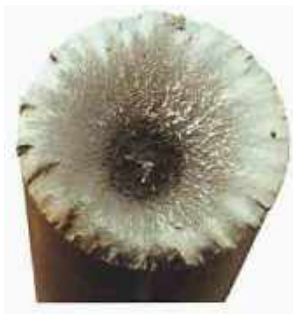
II-2-2-4. Perpendicular, torsional fatigue rupture.

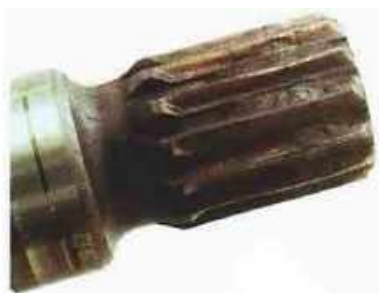
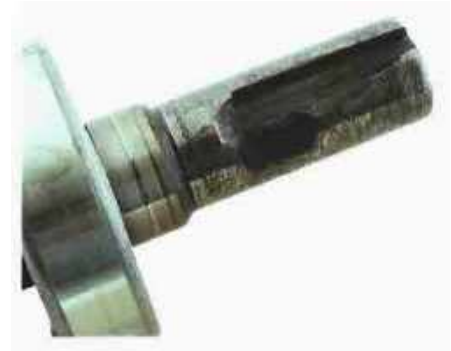
II-2-3. Shaft splines/ keyed shaft worn out on total length.

- Incorrect shaft/ coupling connection
- Insufficient lubrication (Grease)
- Over torque values
- Highly cycled

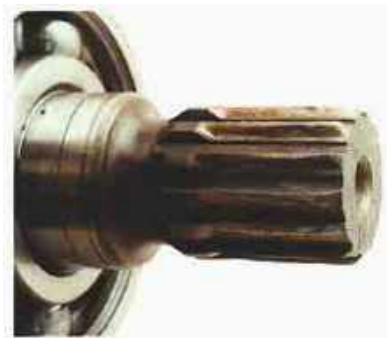
II-2-4. Shaft splines/ keyed shafted worn out on part of the length.

- Over torque value
- Utilized key surface or splined surface was too small

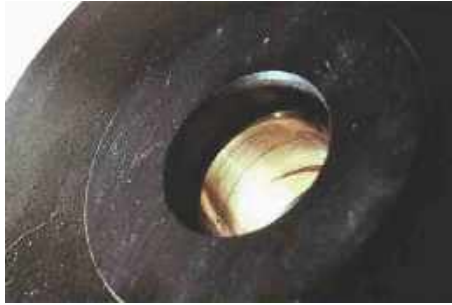
II-2-5-1. Front or back bearing/ bushing with heavy wear

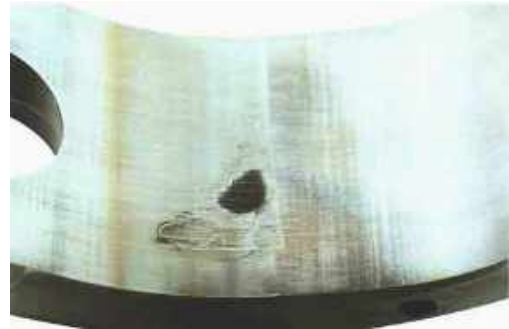
II-2-6. Cam ring marked by the rotor on the smallest diameter. The contact between the rotor and the cam ring is important, damage will transform the hardness of the cam ring and create local tensions (cracks).

- Problems on shafts p5-6, II-1-1
- Incorrect shaft/ coupling connection p7, 10, II-1-2

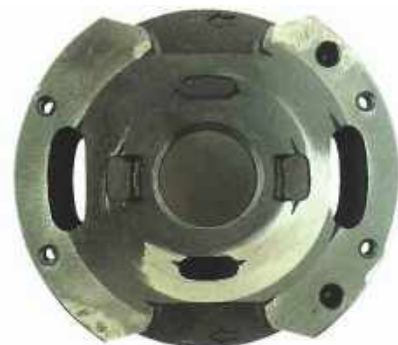
II-2-8. Dissymmetrical wear on the side plates

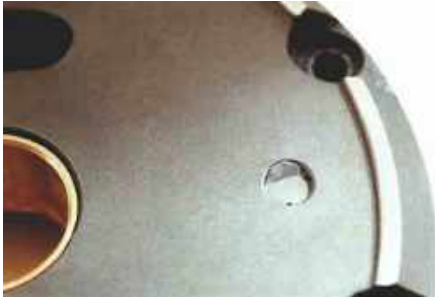
II-2-9. Dowel pin broken

- Over torque limits
- Cartridge not properly mounted in the housing

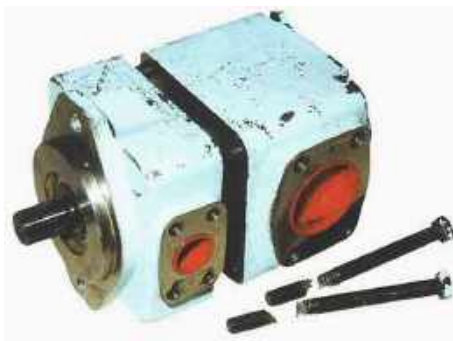
II-2-11. Broken screws

- Loose pump fasteners

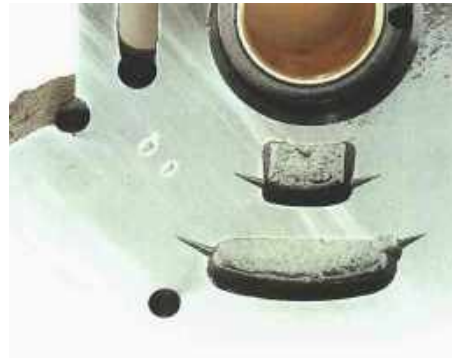
- Titled vanes marked the port plate but the pump did not rotate.

- Cartridge not properly assembled

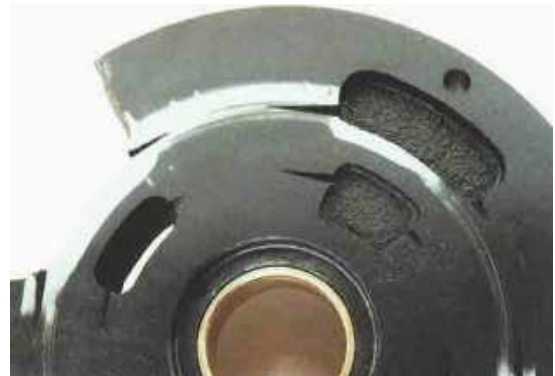
- Titled vanes but the pump rotated. The result is scars on the port plate.

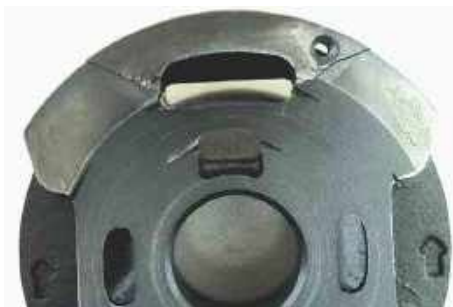
This is a brutal high peak of pressure. The consequence is that the mechanical strength of the material is exceeded. This will cause some brutal failures of components such as the side plates (on the high pressure distribution area), the rotor (split), the cam ring (cracked), the shaft (broken), the dowel pin (cut in two).

II-3-3-1. Cracks or rupture of the pressure plate

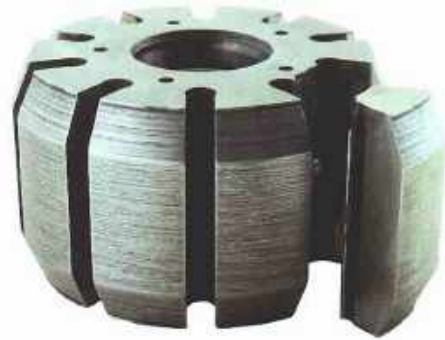
II-3-3-2. Cracks or rupture of the rotor

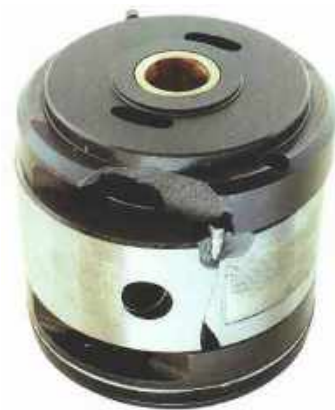
II-3-3-3. Cam ring cracked

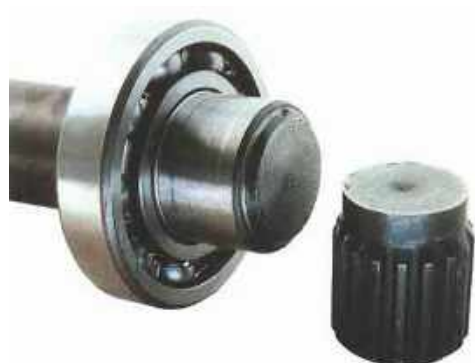
II-3-3-4. Shaft broken : perpendicular "clean cut"

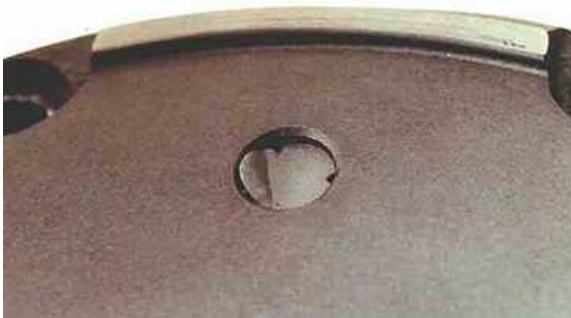
II-3-3-5. Dowel pin cut in two

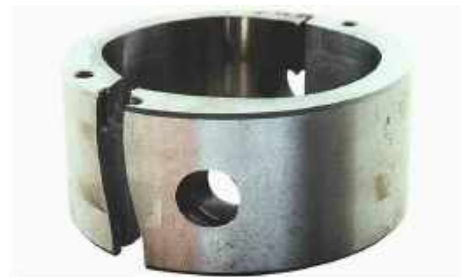
- rupture/ cracks

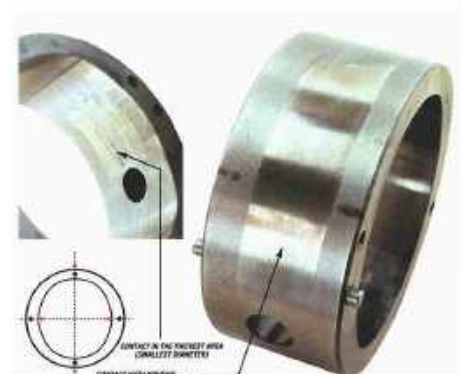
- rotor/ cam ring contact in the "small diameter"

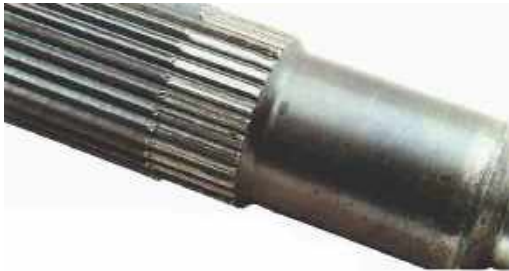
- internal spline worn

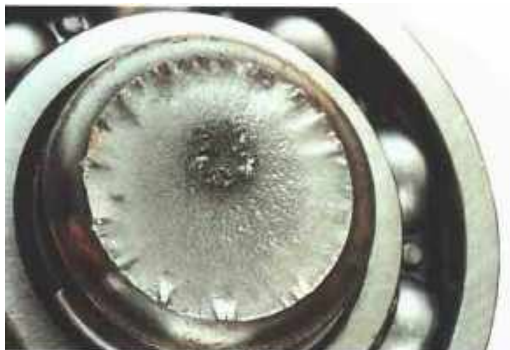
Perpendicular : few cycles but very high torque

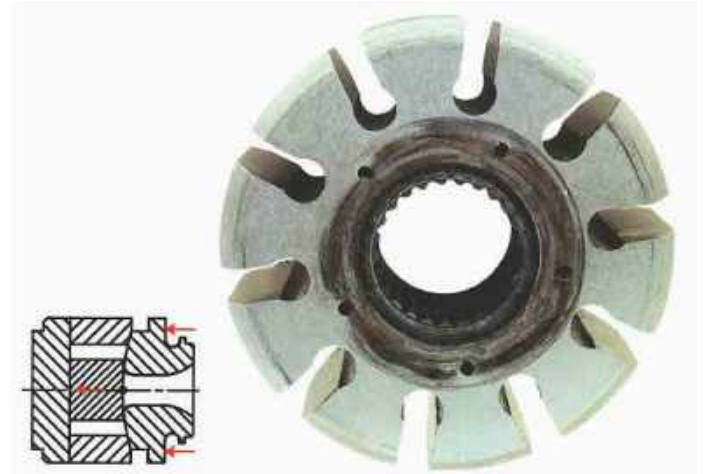
II-3-5-4. Side plates deformations = contact on the smallest diameter of the rotor.

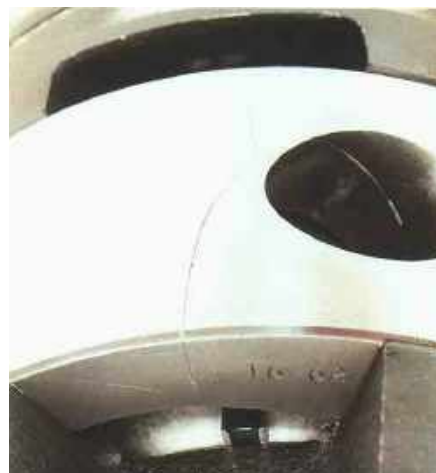
II-3-7-1. Cam ring fatigue rupture

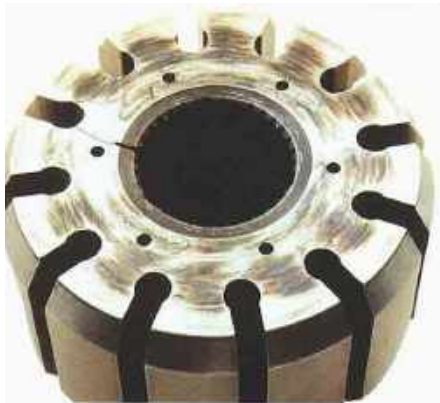
II-3-7-2. Rotor/ side plates seizure : This is due to a very strong cavitation when the pressure decrease is dramatic. The sudden flow required is so large that the instant local velocity rises and creates the cavitation.

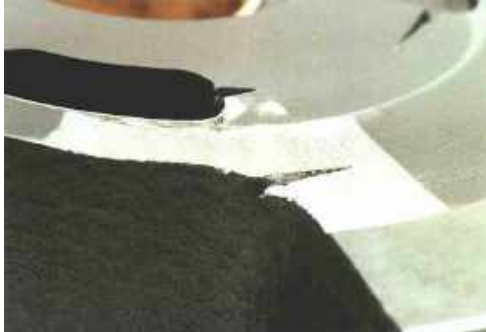
II-4-2-2-1. If the quantity of air is erratic or not too heavy, the effects are scores only on the port plates in the suction area.

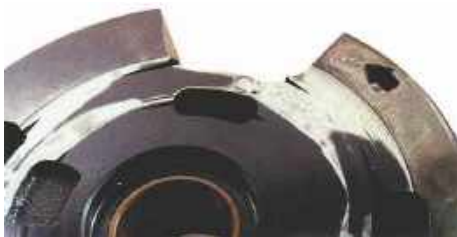
II-4-2-2-2. If under very severe aeration, this groove can mark deeply the port plates from the suction area to the outlet area. The width of the groove is then the width of the vane.

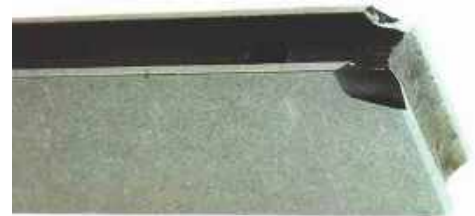
II-4-2-2-3. In very heavy air conditions, the vane is so unbalanced that it can even sometimes break.

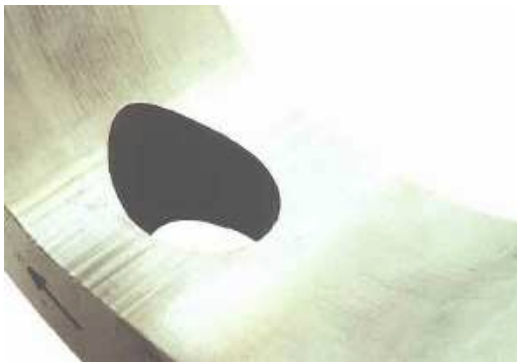
II-4-2-4-2. Ripples on the cam ring : The vanes are hydrostatically balanced to avoid excessive loads on the vane lips. Under suction cycle, the pin compensates the out of balanced load due to the cam profile. When the depression is over the design limit, the vane bounces, creating ripples on the cam ring profile. The depth of these marks is proportional to the strength of the depression.

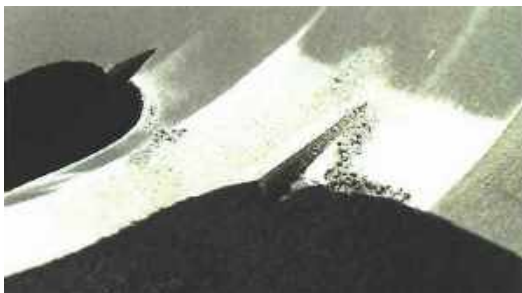
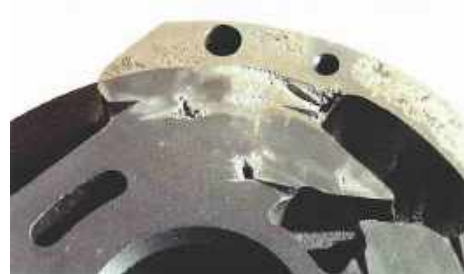
II-4-2-4-3. Craters : These erosion craters are sometimes difficult to observe as the pump may have already seized. These craters come from erosion, caused either by an explosion/implosion, or by depressurisation.

When the fluid trapped between the two vanes is sucked in with a certain percentage of air in suspension, an explosion can occur. When this trapped volume is compressed, these air bubbles explode and create craters in the side plates in the area between the suction port and the pressure port, around the pressure bleed slots.

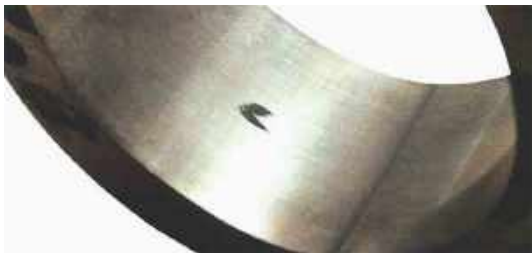
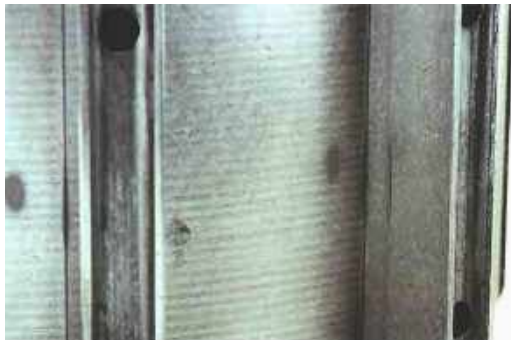
II-4-2-4-4. "Black marks" : The local depression consequences can be seen on the vanes (top lips and on the center of the vane), on the port plates (in the inlet area) and on the center of the cam ring (just after the inlet "feeding hole"). These "black marks" can be transformed into small craters in the port plates near the outlet bleed slots as the air bubbles explosion occurs.

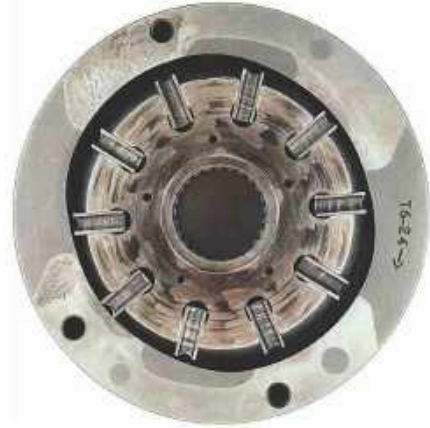
II-4-2-4-5. Seizure of the pump :

Due to a lack of fluid, the vacuum generated, when really severe, will suck the oil on the side of the pump (between the rotor and the side plates). This will have the effect of breaking the film of oil that lubricates these surfaces. The surfaces will then heat-up and this local over-heat will modify the standard lubricity into a dry friction. The result is a seizure between the rotor and the side plates. (This heavy contamination coming from the creation of craters, can cause the particles to effect the lubrication of the pump and lead to seizure.)

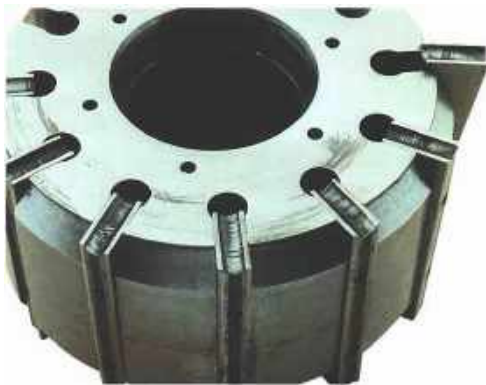
a). The vane lips edges. The particles in the fluid will have a grinding effect between the top of the lips and the cam ring profile. When the contaminant is too big or too stiff, the vane lip edges can break.

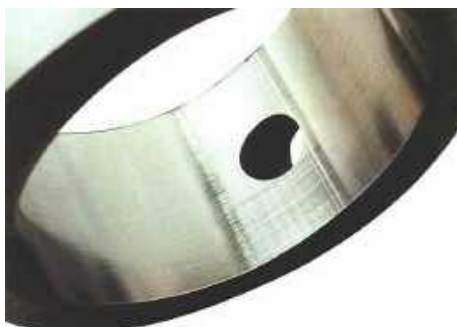
Between the vane lip and the cam ring, if the film of oil is contaminated. This will wear the inner surface of the cam ring.

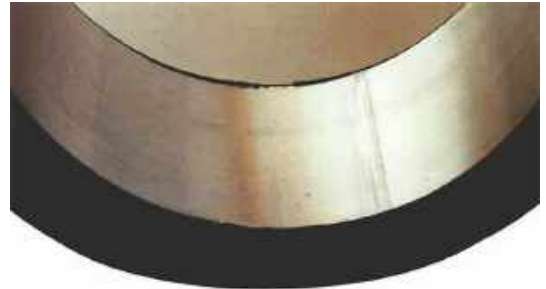
On the edge of the cam ring contour, (with a slight chamfer when new), you will find a sharp angle (edge). If the wear is heavy, the cam ring can have little burrs in this area.

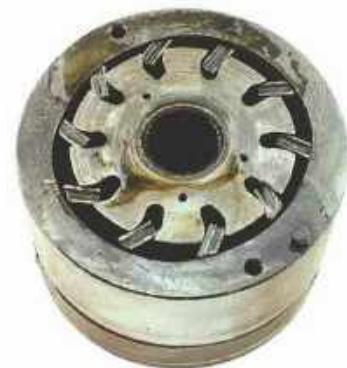
In the rotors' slots, the rubbing wear between the slots and the vanes will also lead to vertical contamination marks. (page 32 II-4-4-2b)

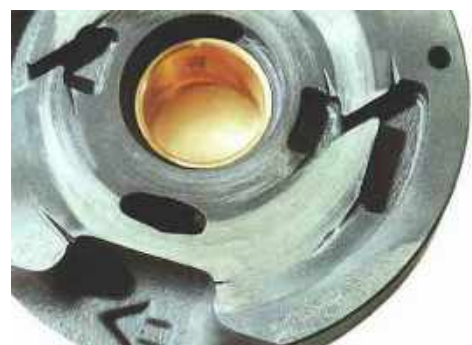
When the particles in suspension in the fluid are greater than half of the clearance between the thickness of the rotor and the thickness of the cam ring, seizure occurs in the peripheral diameter of the rotor and the port plates.

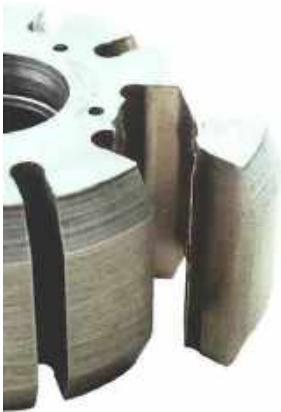
The rubbing effect will also appear in-between the side of the rotor and the side plates. This will create a torque between the two vane slots. This torque causes a reasonably high level of fatigue in the materials' weakest area, between the two bulb slots of the rotor. If this fatigue level exceeds the design limits, this portion of the rotor will break.

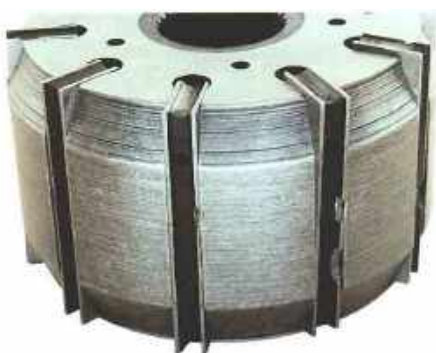
Large contamination particle damage (like the "carbon" welding balls) are usually seen on the port plates (blocked in the slots) or/and on the top of the vanes/rotor. In each case, they will have an effect on the vane lips, either on the top or on the sides. The "rubbing" action will either destroy the vane lips or weld the vane to the rotor, breaking the cam ring.

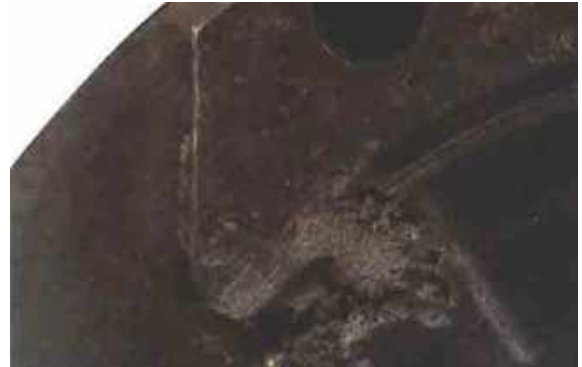
Another sign of contaminated oil is some possible erosion craters on the port plates at the inlet/suction bleed slots area. These erosion craters would come from the abrasive fine particles in a local high velocity area.

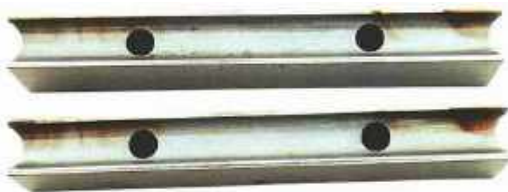
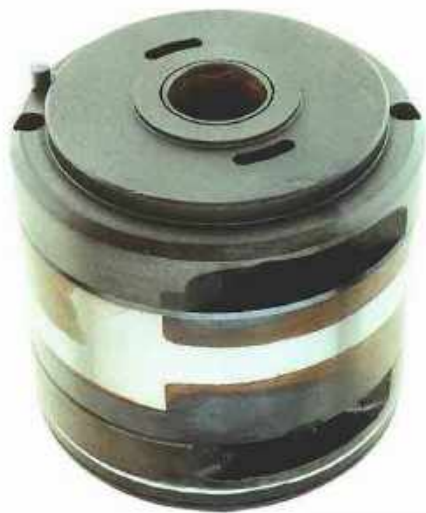
On the cartridge, it changes the colour of the bronze bushing (due to the modification of the acidity) and leaves a deposit on the external diameter.

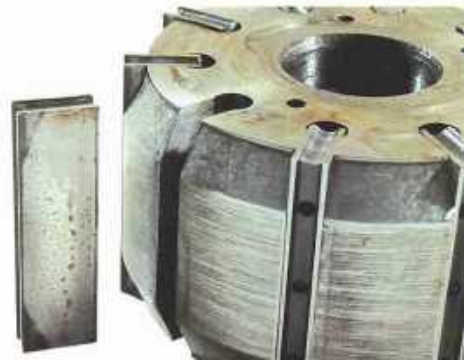
II-4-6-2. - The fluid can produce foaming because of the steam. The appearance of foaming oil due to water is a milky or creamy typical aspect. The consequences are identical to the aerated fluid.

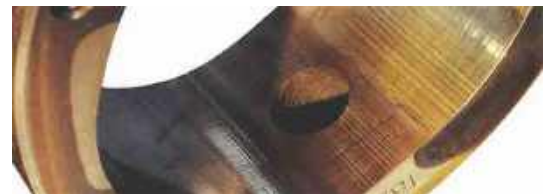
II-4-6-3. - The fluid compressibility will fluctuate and therefore destabilize the vanes. This will be seen on the cam ring surface as ripples and on the sharp vane lips edges. In this case, the noise level will be high and the flow & pressure capabilities deteriorated.

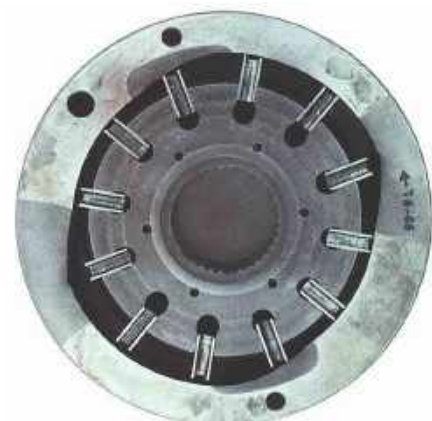
II-4-6-4. - Due to these fluid transformations, the mechanical consequences go from performance being deteriorated to the destruction of the pump if the local temperatures are extreme (Here, phosphate oil additive deposit).

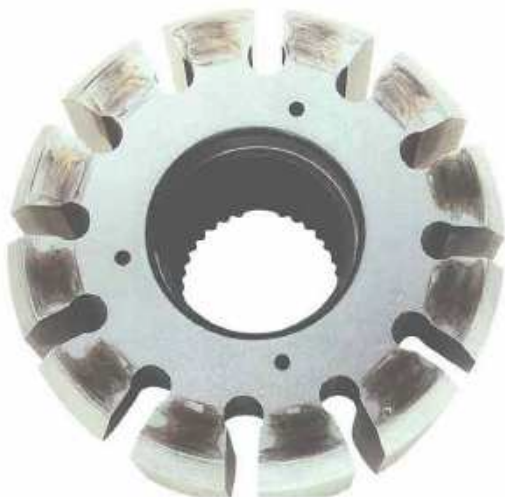
- Seizure due to the high cavitation not allowing the rotating group to be lubricated.

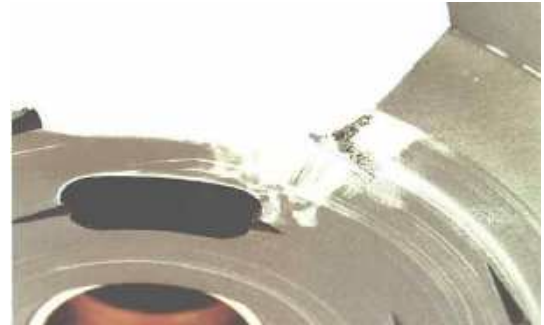
- Erosion on the port plates.

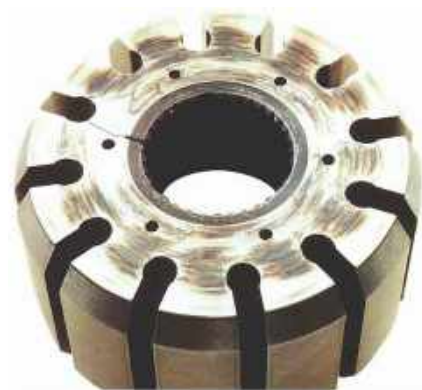
- Scars on the side plates & rotor due to a bad lubricity.
