Hydraulic Vane Pump Troubleshooting Booklet

Catalog 2020

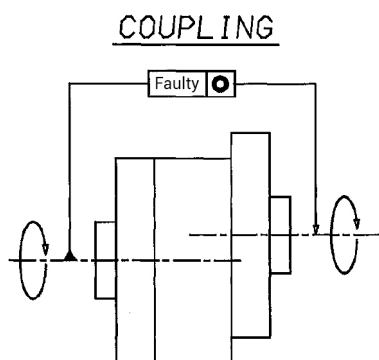
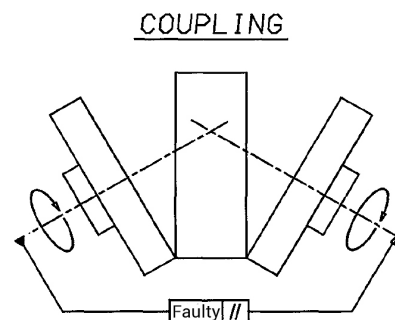
a) Misalignment

Incorrect alignment, faulty mechanical link (bracket, chassis deformation, bad bell housing, loose damping elements) can create :

Consequence page for a) and b)

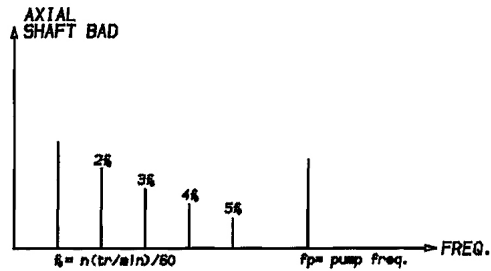
II-1-1-2. Unbalanced coupling = radial load.

II-1-1-3. Too tight load on a belt driven system
(belt drives not recommended)

- Shaft rupture p9, II-2-2-2
- Bushing p11, II-2-5
- Marked Cam ring p11, II-2-6
- Shaft seal problem p11, II-2-7
- Dissymmetrical wear on port plate p11, II-2-8

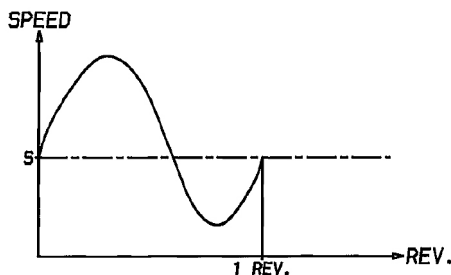
II-1-1-4. Non-homokinetic transmission due to unbalanced cardan shaft (or universal joint).

II-1-1-5. Excessive moment of inertia due to heavy couplings (like chain couplings) or very large diameter couplings.

- Shaft rupture p9, II-2-2-2
- Bushing p11, II-2-5
- Marked Cam ring p11, II-2-6
- Shaft seal problem p11, II-2-7

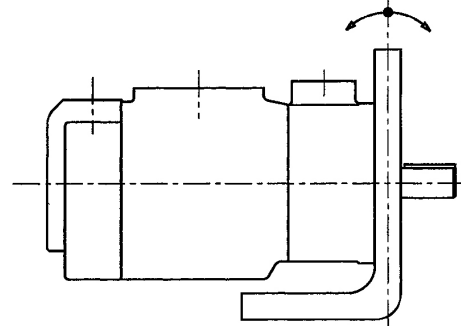
II-1-1-6. Bracket chasis deformation (when pump under load).

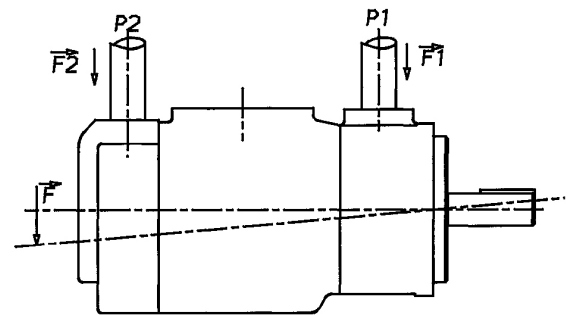
II-1-1-7. Hose strain (reaction) force (brutal pressure compression / decompression, rigid hoses mounting strain...).

- Shaft rupture p9, II-2-2-1
- Bushing problems p9, II-2-2-2
- Marked Cam ring p11, II-2-5
- Seal problems p11, II-2-6
- Wear on port plate p11, II-2-7
- p11, II-2-8

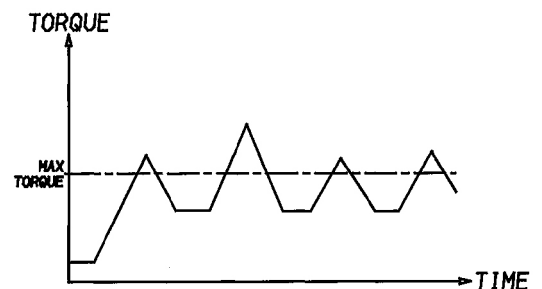
II-1-1-8. Over torque limits (too high pressure versus displacement for the capacity of the shaft chosen)

- Shaft rupture (torsional fatigue) p9, II-2-2-3
- Shaft wear p10, II-2-3
- p10, II-2-4

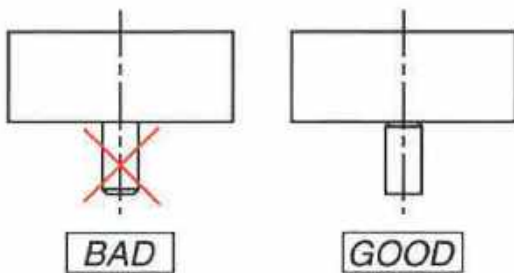
II-1-5. Hollow pin-vane incorrectly mounted in the HT6*M, Mobile version (pin up side down).

- Noisy
- Flow unstable

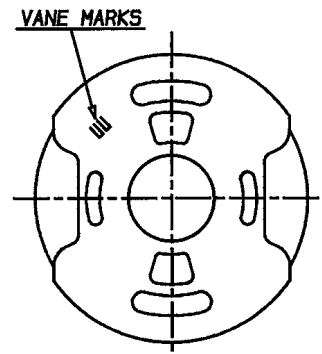
II-1-7. Marks on distribution plates that disturb the cycle of the pump. Even a small scratch between the inlet & the pressure area can destabilize the vane.

- Vane marks
- Noisy
- Pressure limited
- Flow unconstant

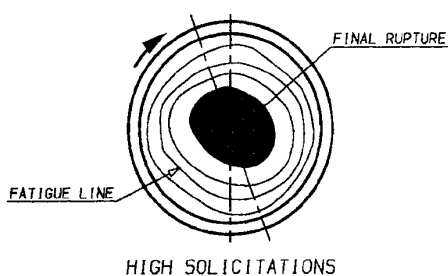
ROTATIONAL BENDING FATIGUE

Incident page for II-2-2-1 and II-2-2-2

- Bad alignment p5, II-1-1a
- Out of squareness p5, II-1-1b
- Unbalanced coupling p6, II-1-1-2
- Too high radial load p6, II-1-1-3
- Non homokinetic P6, II-1-1-4
- Too great moment of inertia P6, II-1-1-5
- Bracket chassis deformation P6, II-1-1-6
- Hose strain force P6, II-1-1-7
- Bad shaft/ Coupling link P7, II-1-2-1

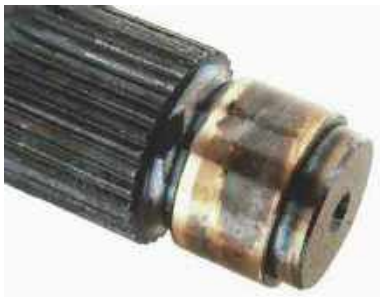
II-2-5-2. Bushing "welded" on the shaft

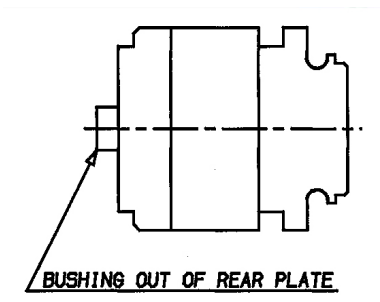
II-2-5-3. Back bushing moving out of the rear port plate

- Problems on shafts p5-6, II-1-1
- Incorrect shaft/ coupling connection p7, II-1-2

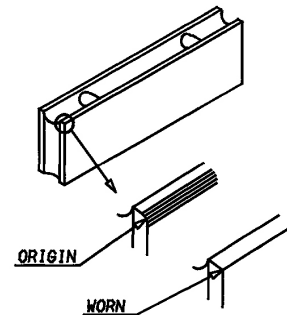
II-3-5-1. Vanes

II-3-5. The consequences of cycled overpressurization :

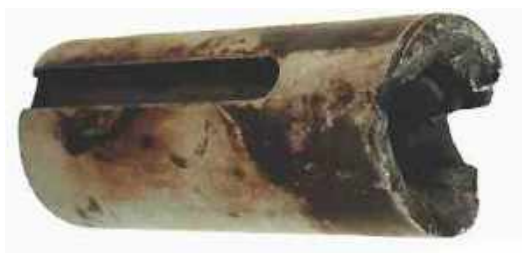
Twisted : often under high cycling

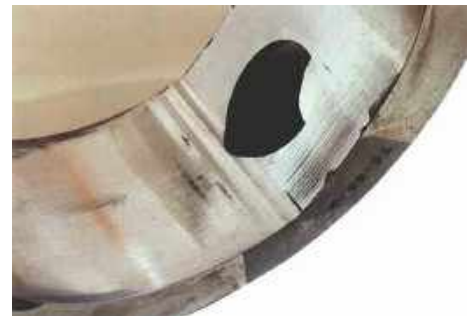
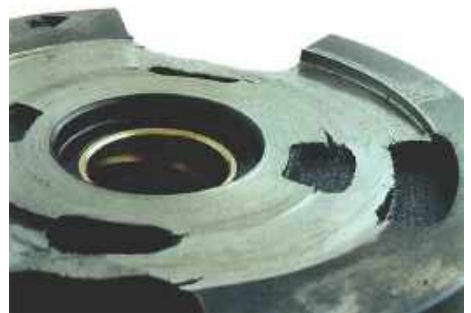
II-4-2-2-4. Noisy

Before suffering such a disastrous wear, the vanes being so unsteady will make a lot of noise, the flow will not be the as required and/or the pressure level will not be obtained. The physical aspect of the oil will be "milky" on the surface as the oil and the air create a foam.

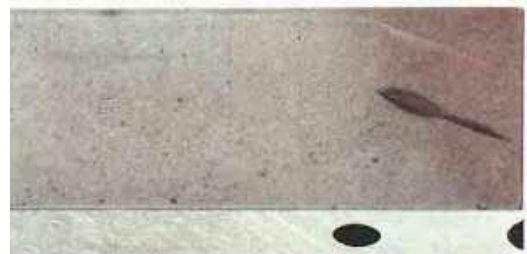
- Vanes

II-4-2-4-4. "Black marks" : The local depression consequences can be seen on the vanes (top lips and on the center of the vane), on the port plates (in the inlet area) and on the center of the cam ring (just after the inlet "feeding hole"). These "black marks" can be transformed into small craters in the port plates near the outlet bleed slots as the air bubbles explosion occurs.
